# Quality assurance of timber structures

## Research report

<b>Report Nr.</b>	77FE-008098-V01
<b>Contract Nr.</b>	2016.17
<b>Classification</b>	Public
<b>Date</b>	24.01.2019
<b>Client</b>	Bundesamt für Umwelt BAFU Abteilung Wald, WHFF CH-3003 Bern
<b>Address of the research unit</b>	Bern University of Applied Sciences Institute for Timber Constructions, Structures and Architecture Solothurnstrasse 102, CH-2504 Biel 6 Tel / Fax +41 (0)32 344 03 41/91 <a href="http://www.ahb.bfh.ch">www.ahb.bfh.ch</a>
<b>Authors</b>	Bettina Franke, Steffen Franke, Marcus Schiere, Andreas Müller
<b>Project Leader</b>	Prof. Dr. Steffen Franke
<b>Head of the Institute</b>	Prof. Andreas Müller

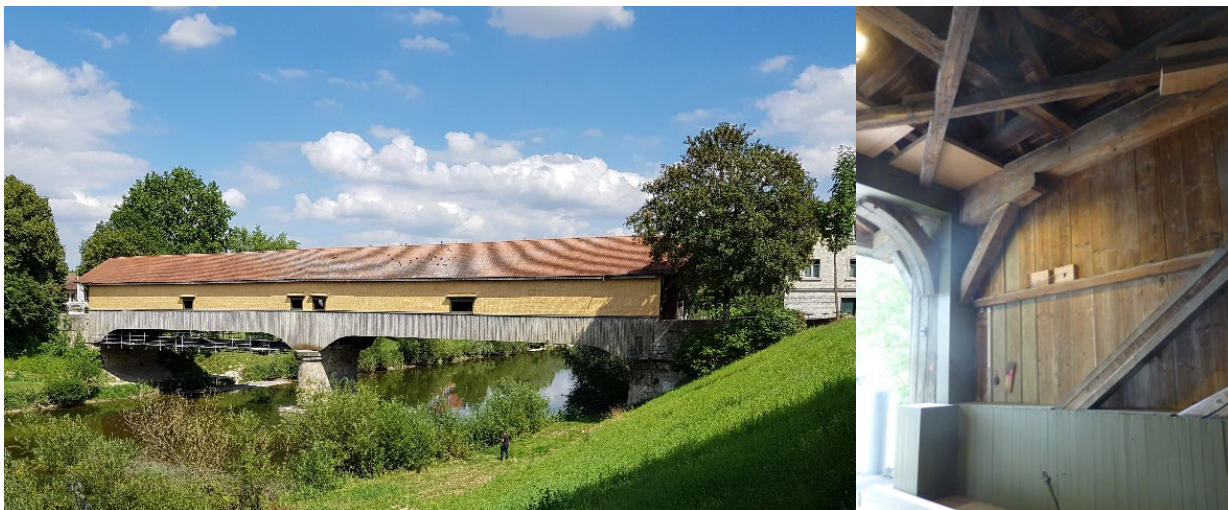
*Figure 30: Bridge crossing the Thur in the village of Andelfingen with a view on the instrumentation and two dummy blocks on the north side of the bridge*

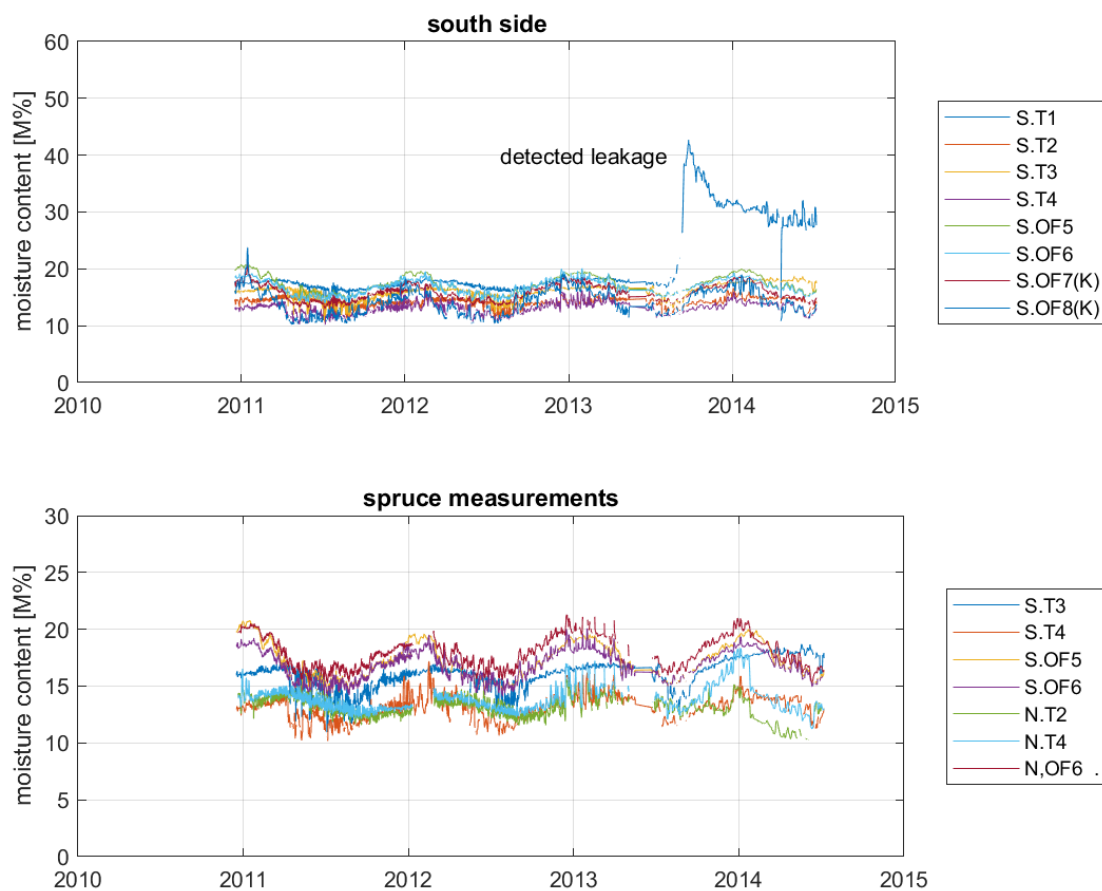
Figure 35: A summary of the moisture content measurements made on the Obermatt bridge where a leakage could clearly be detected thanks to the installed monitoring system.

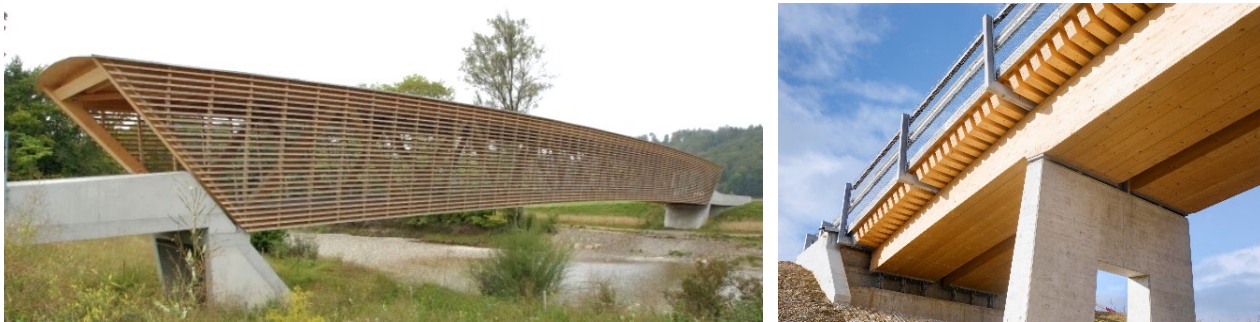
Figure 39: Bridge Neumatt with protected truss system using gladding (left) and Bridge Horen with weather protection by structural overhang

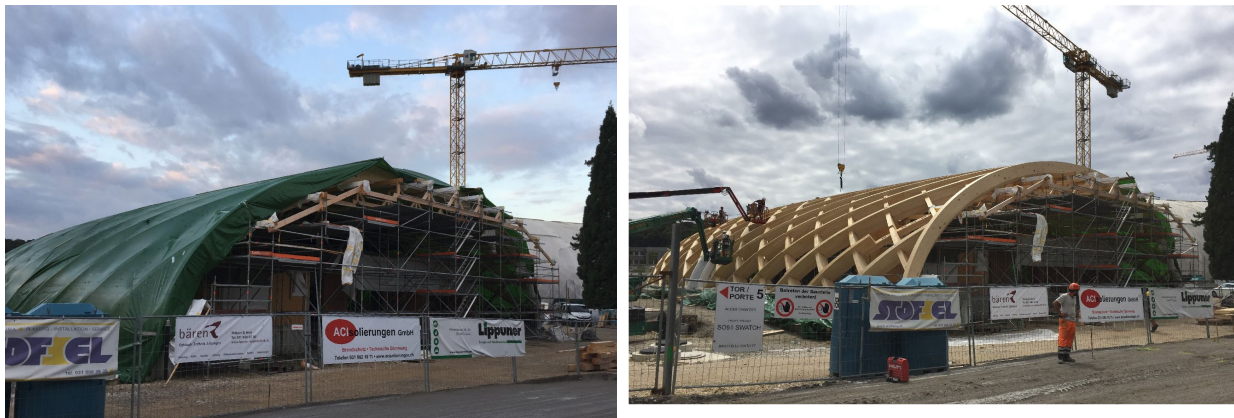
Figure 67: Efficient protection during evenings, nights and weekends or during rain; removing of the protection during the working times (Swatch building, Biel/Bienne)

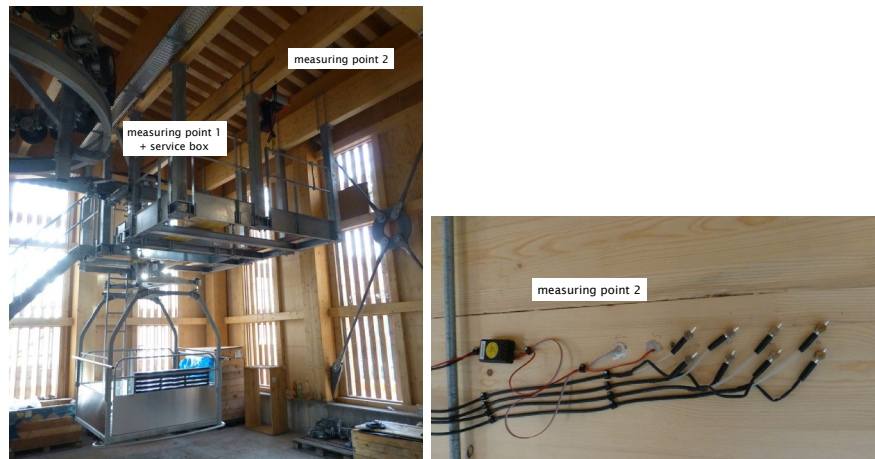
Figure 3: Measured climate and moisture content in the cable car station of Nättschen

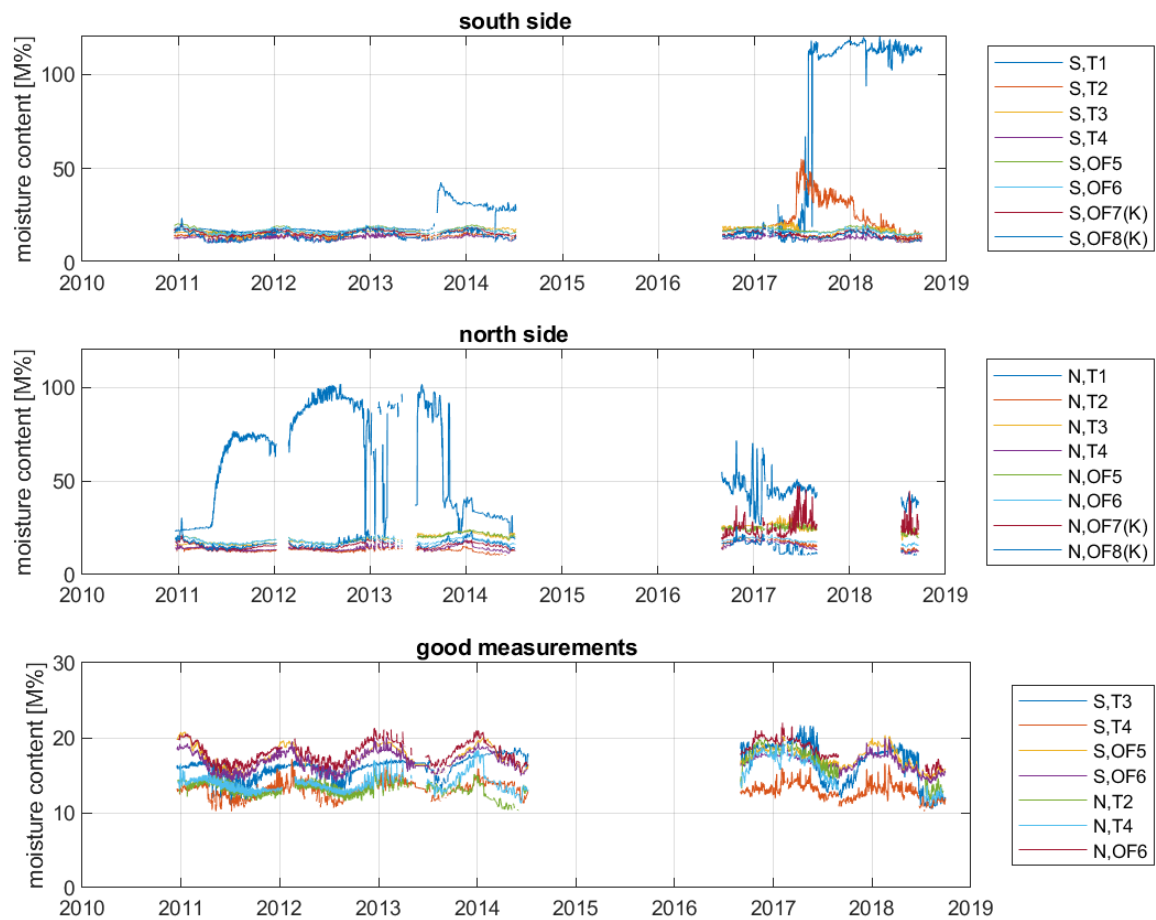
Figure 14: Measured moisture content made on the Obermatt bridge during almost eight years including a gap of two years
